Manhole Inspection Summary

Manhole # S21M__048MH

Insp Date: **2/24/09 11:46 AM**

Location Address: **549 S MONROE ST**

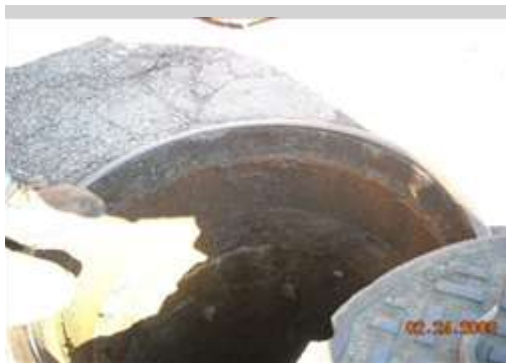
MISC.

Subject To Ponding: **Sheeting**

INFLOW EVIDENCE FROM SHEETING

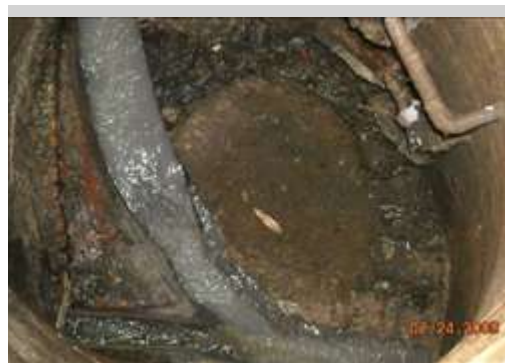
Defect 3

Condition: ☐ Sound ☐ Cracked ☐ Root Intrusion ☐ Deteriorated ☐ Leaks ☒ Debris

DEBRIS ON BENCH

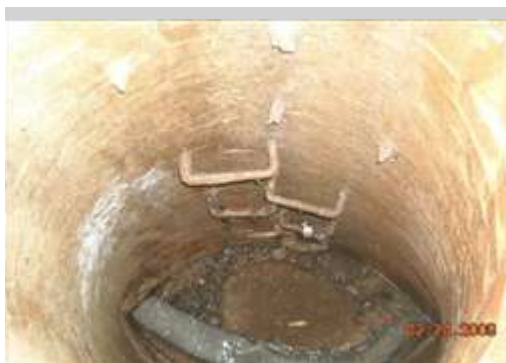
Defect 2

Count: **6**

Missing: **2**

☒ Corroded

CORRODED AND MISSING STEPS

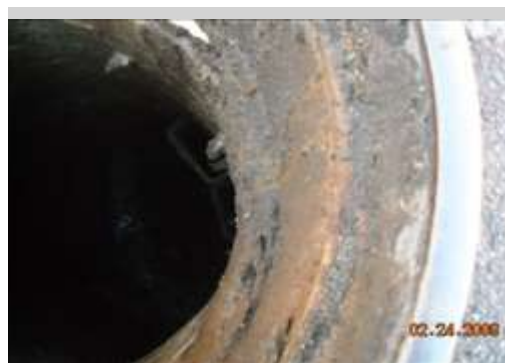
Defect 1

Offset: **1** (in.)

FRAME OFFSET

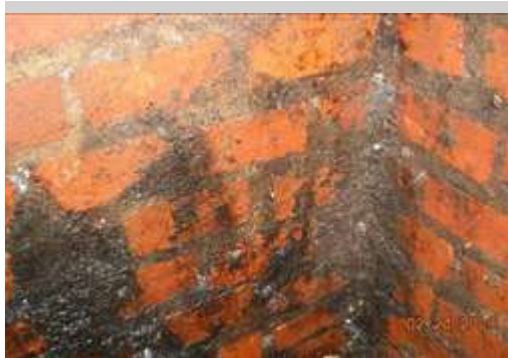
Defect 5

Infiltration: ☐ None ☐ Joint ☐ Cracks ☐ Mortar ☐ Roots ☒ Wall

INFILTRATION @ BARREL WALL

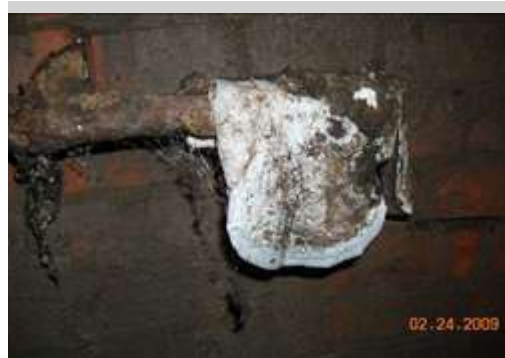
Defect 4

☒ Evidence Of Surcharge

Depth: **5**

EVIDENCE OF SURCHARGE

Comments **HEAVY CLEANING FROM DOWN STREAM MANHOLE S21M__022MH TO REMOVE GREASE DEPOSITS AND ALEAVIATE SURCHARGE; ASPHALT IS CRACKED AND DETERIORATED AROUND FRAME**

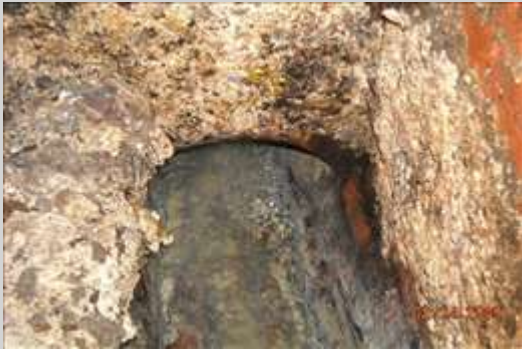
12 O'Clock Outflow

10 in. Circular Gravity Sewer
Pipe Out @ 12 O'Clock

Pipe Height: **10.8** (in.) Rod and Bar (Angled)
Pipe Material: **Clay** ☐ Pipe Lined
Invert Depth: **13.65** (ft.) Flow Characteristics: **Fast**
Deposits: ☐ None ☐ Mud ☐ Sludge ☐ Debris ☒ Grease
Silt Depth: **1** (in.) Deposits Extent: **Light**
Infiltration: **Evidence** Pipe Seal Cond: **Unknown**

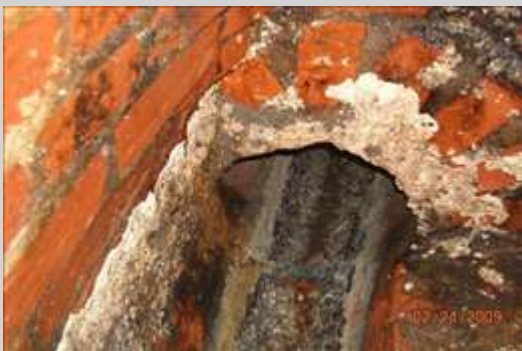
6 O'Clock Inflow

8 in. Circular Gravity Sewer
Pipe In @ 6 O'Clock

Pipe Height: **8.4** (in.) Rod and Bar (Angled)
Pipe Material: **Clay** ☐ Pipe Lined
Invert Depth: **13.25** (ft.) Flow Characteristics: **Fast**
Deposits: ☐ None ☐ Mud ☐ Sludge ☐ Debris ☒ Grease
Silt Depth: **1** (in.) Deposits Extent: **Light**
Infiltration: **None** Pipe Seal Cond: **Sound**

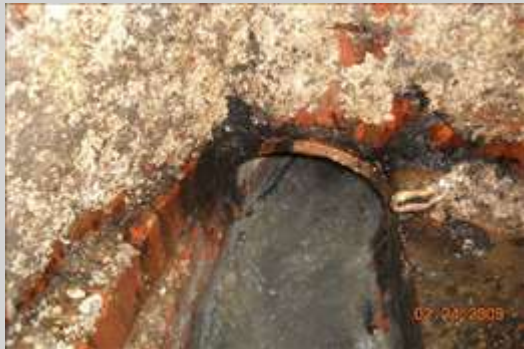
9 O'Clock Inflow

Infiltration: **Weeper** Pipe Seal Cond: **Sound**
